BEACH EROSION CONTROL REPORT ON COOPERATIVE STUDY OF

REVERE AND NANTASKET BEACHES MASSACHUSETTS

NEW ENGLAND DIVISION, CORPS OF ENGINEERS

MARCH 1968

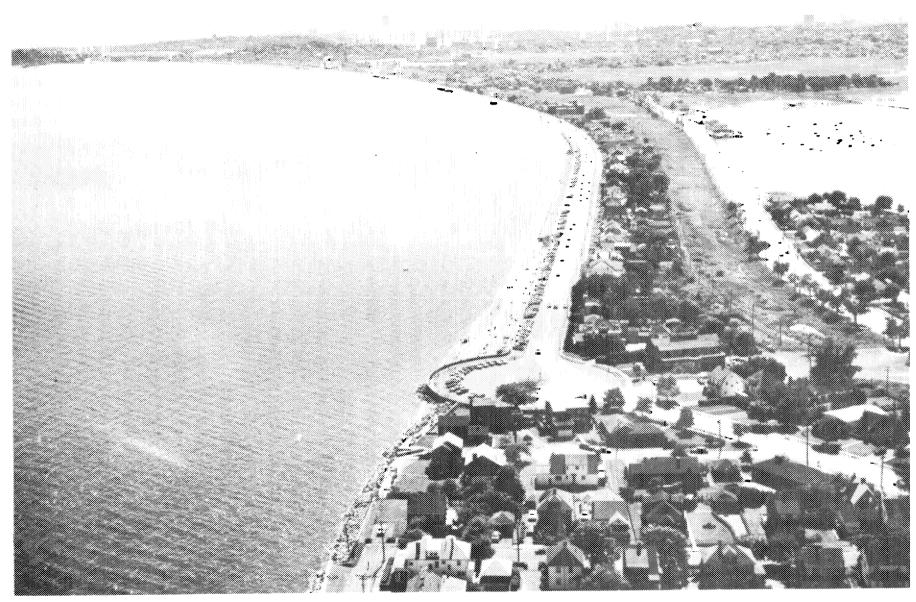
PHOTO 1. Revere Beach, 20 August 1966 - Looking south from Northern Circle during a normal high tide.

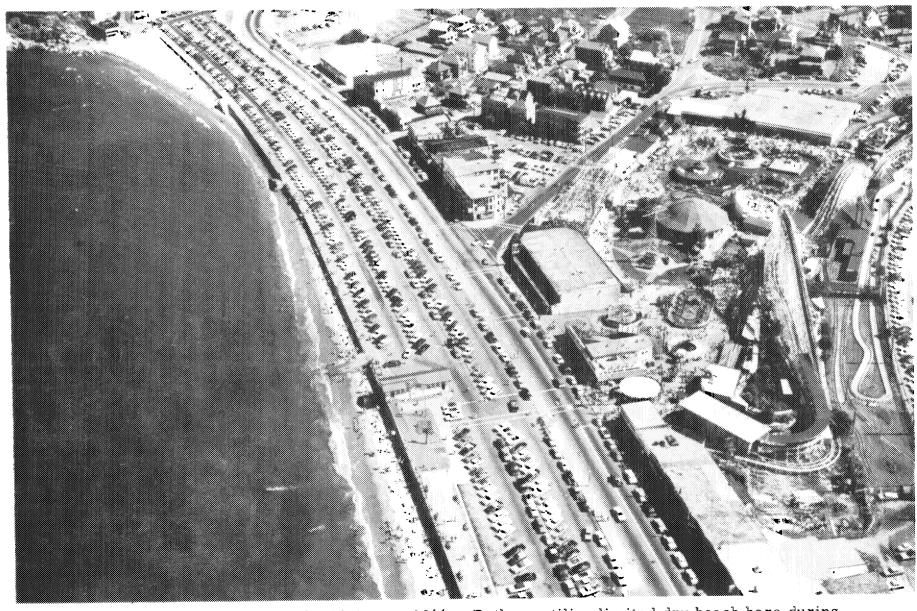
PHOTO 4. Nantasket Beach, 20 August 1966 - Bathers utilize limited dry beach here during high tides.

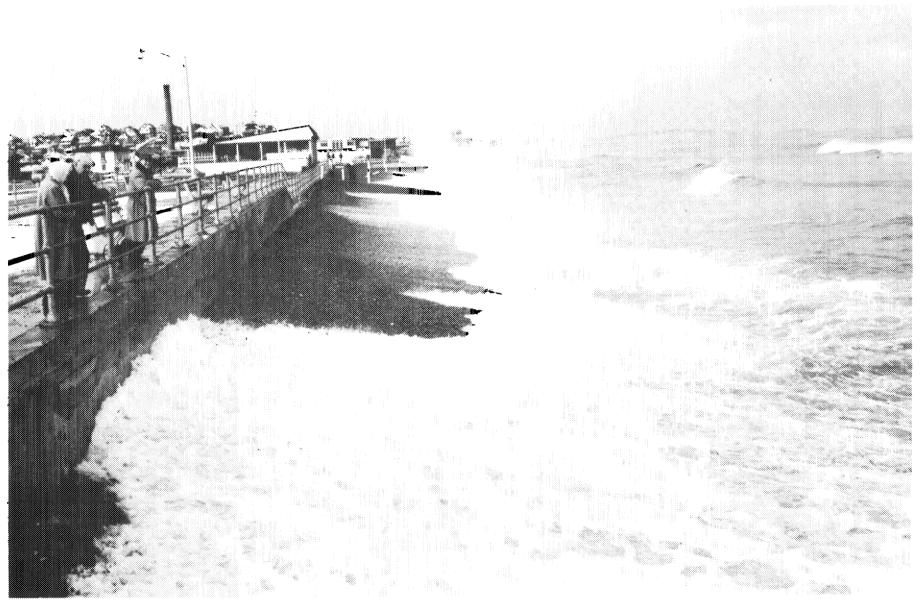
PHOTO 5. Nantasket Beach, 30 December 1959 - Waves pound shorefront as storm of 29 December 1959 moves offshore.

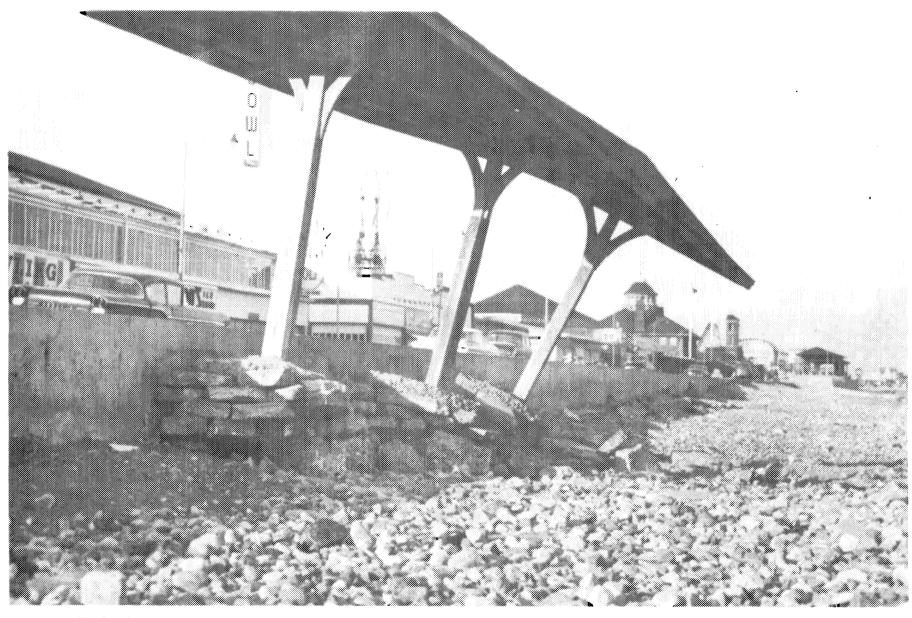
PHOTO 7. Revere Beach, 30 December 1959 - The serious storm of December 1959 eroded sand from beach, exposing foundations of 15 beach shelters.

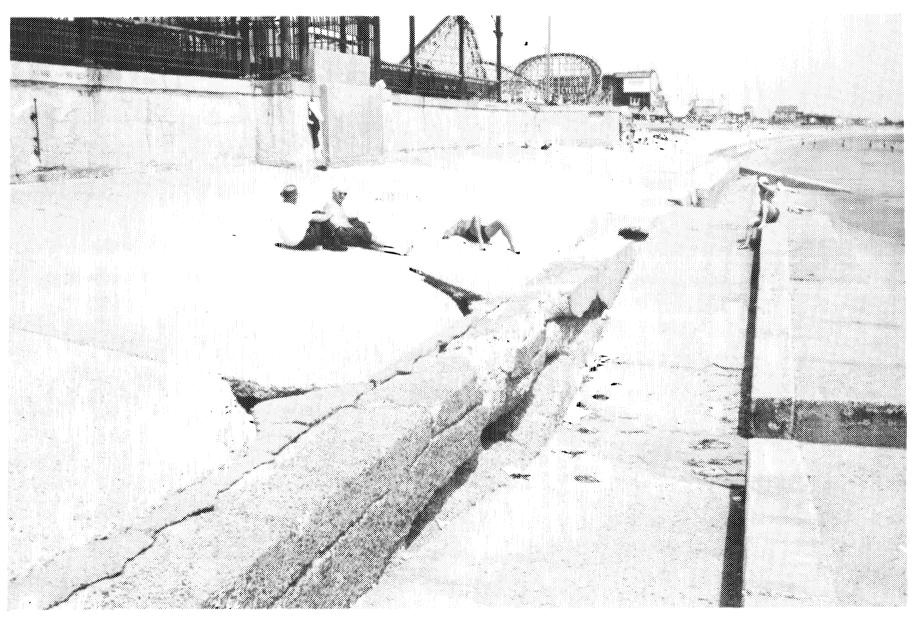
PHOTO 9. Revere Beach, 25 May 1966 - Normal tides reach and storm tides frequently overtop these massive concrete structures, resulting in serious damage.

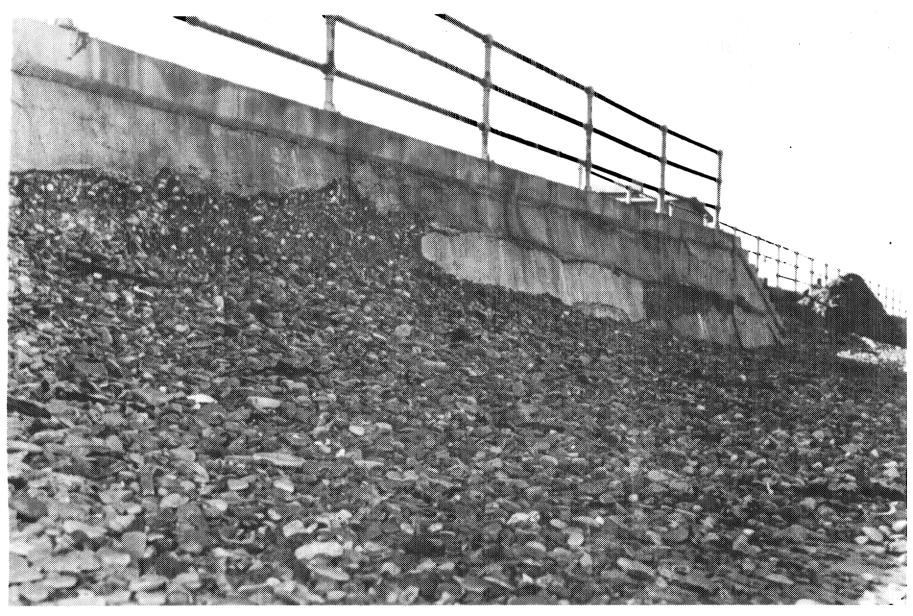
PHOTO 10. Nantasket Beach, 4 March 1966 - Serious storms frequently deposit cobbles along backshore.

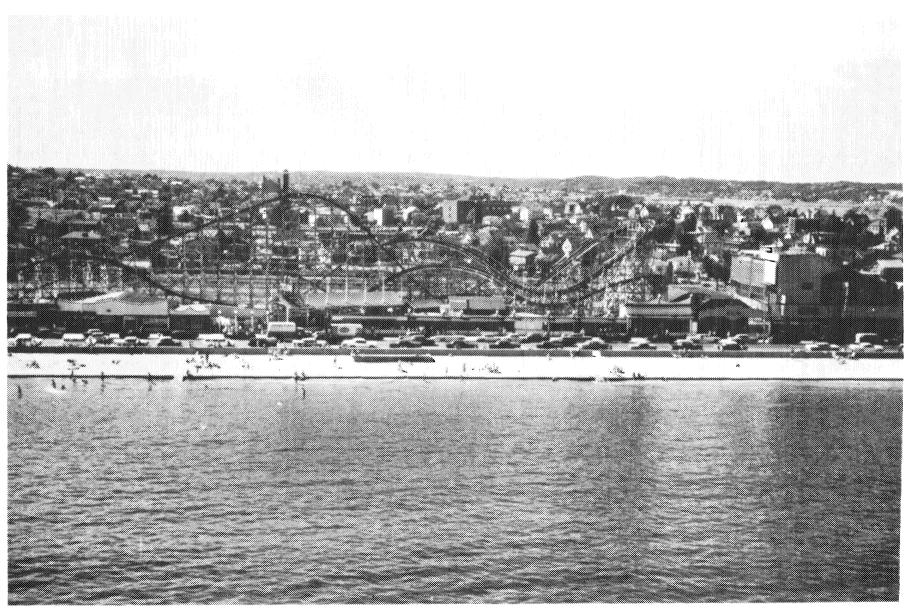
PHOTO 12. Revere Beach, 20 August 1966 - Bathers utilize concrete apron during a normal high tide.
